WL-TR-97-3093

**CORROSION AND FATIGUE STUDY
OF JSTARS AIRCRAFT**

Volume I

**NORTHROP GRUMMAN CORPORATION
MILITARY AIRCRAFT SYSTEM DIVISION
ONE HORNET WAY
EL SEGUNDO, CA 90245**

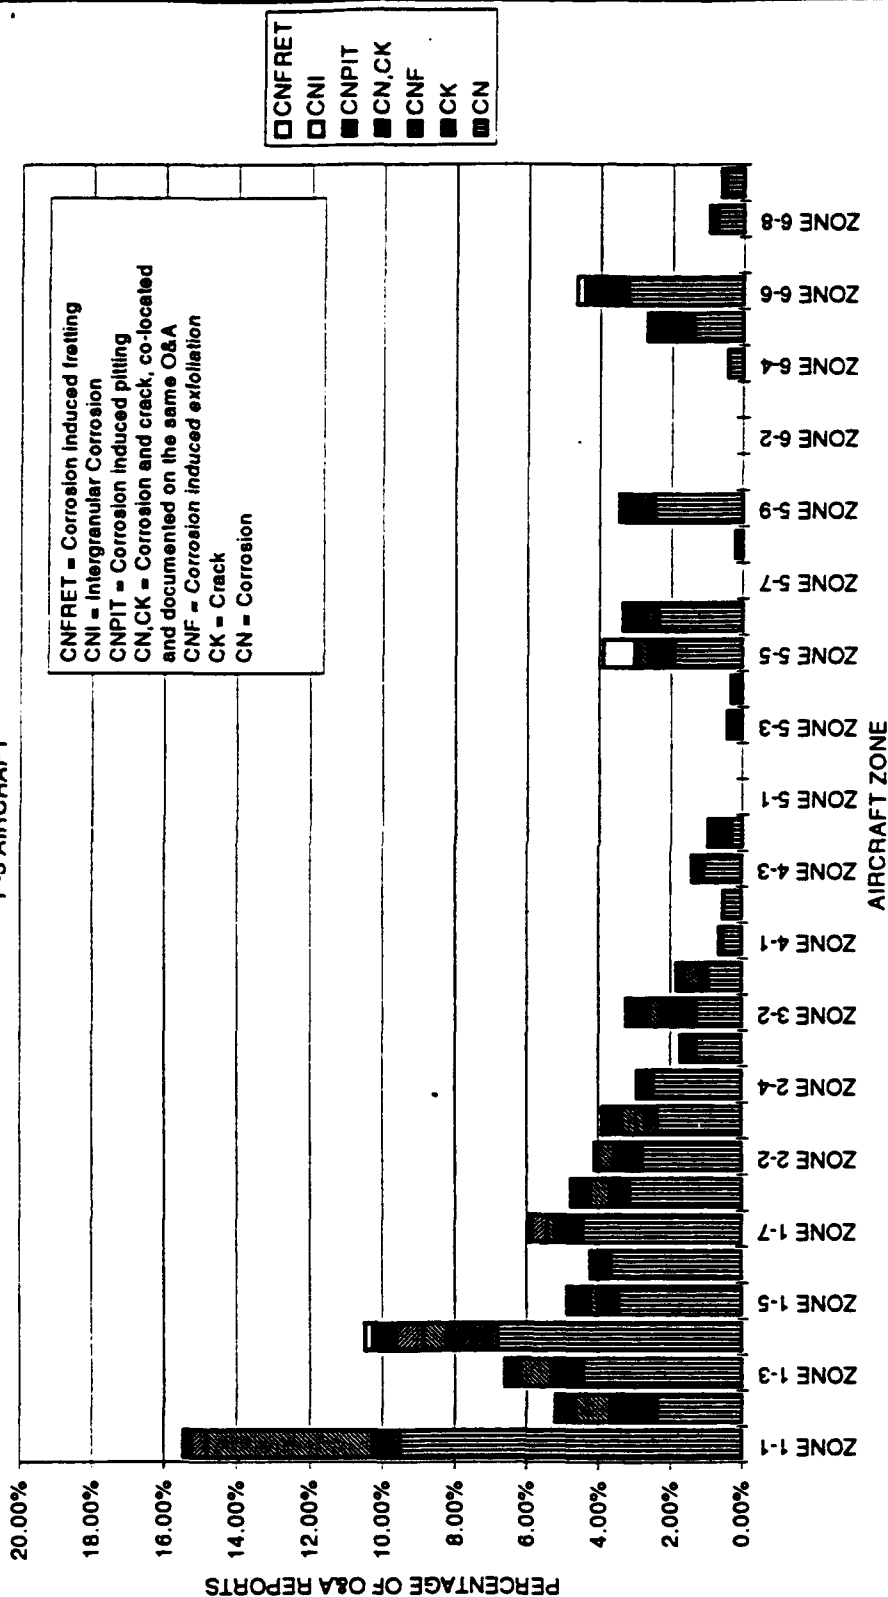
Figure 4.2 and 4.3 report the percentage of over and above (O&A) reports per aircraft zone for P-3 and P-4 respectively. The levels of damage trend consistently between aircraft in zones 1-1, 1-4, 5-5, 5-6, 6-5 and 6-6. The P-4 aircraft has high levels of damage in zones 2-2 and 2-4 which are not present on aircraft P-3. Conversely, the P-3 aircraft has a relatively high level of damage in zone 5-9 not seen on the P-4 aircraft.

Figure 4.2 - Percentage Of O&A Reports Per Aircraft Zone On Joint STARS Aircraft P-3

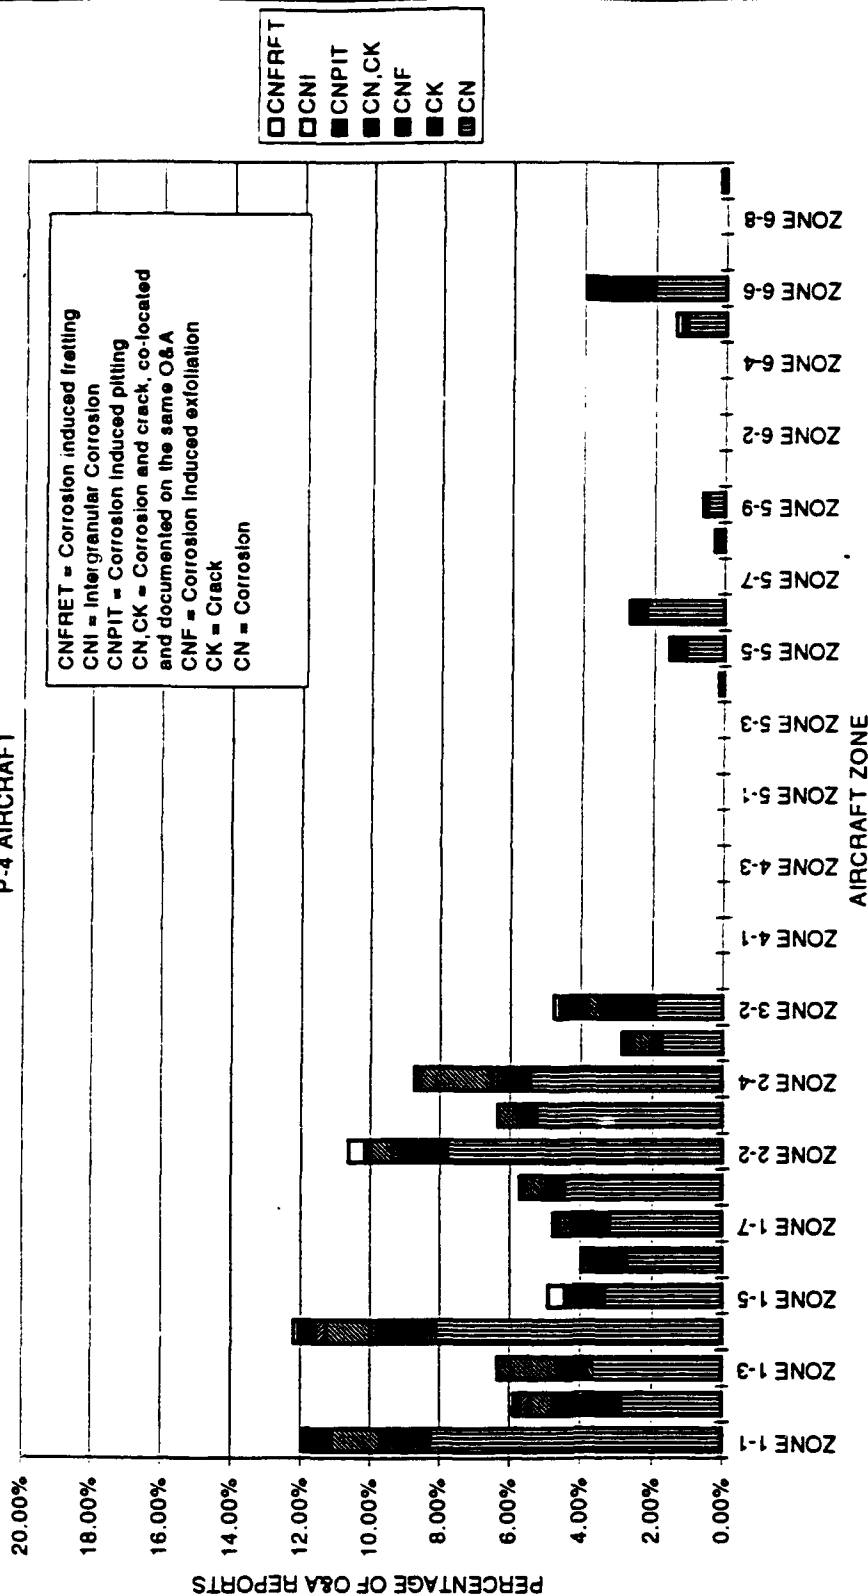
Figure 4.3 - Percentage Of O&A Reports Per Aircraft Zone On Joint STARS Aircraft P-4

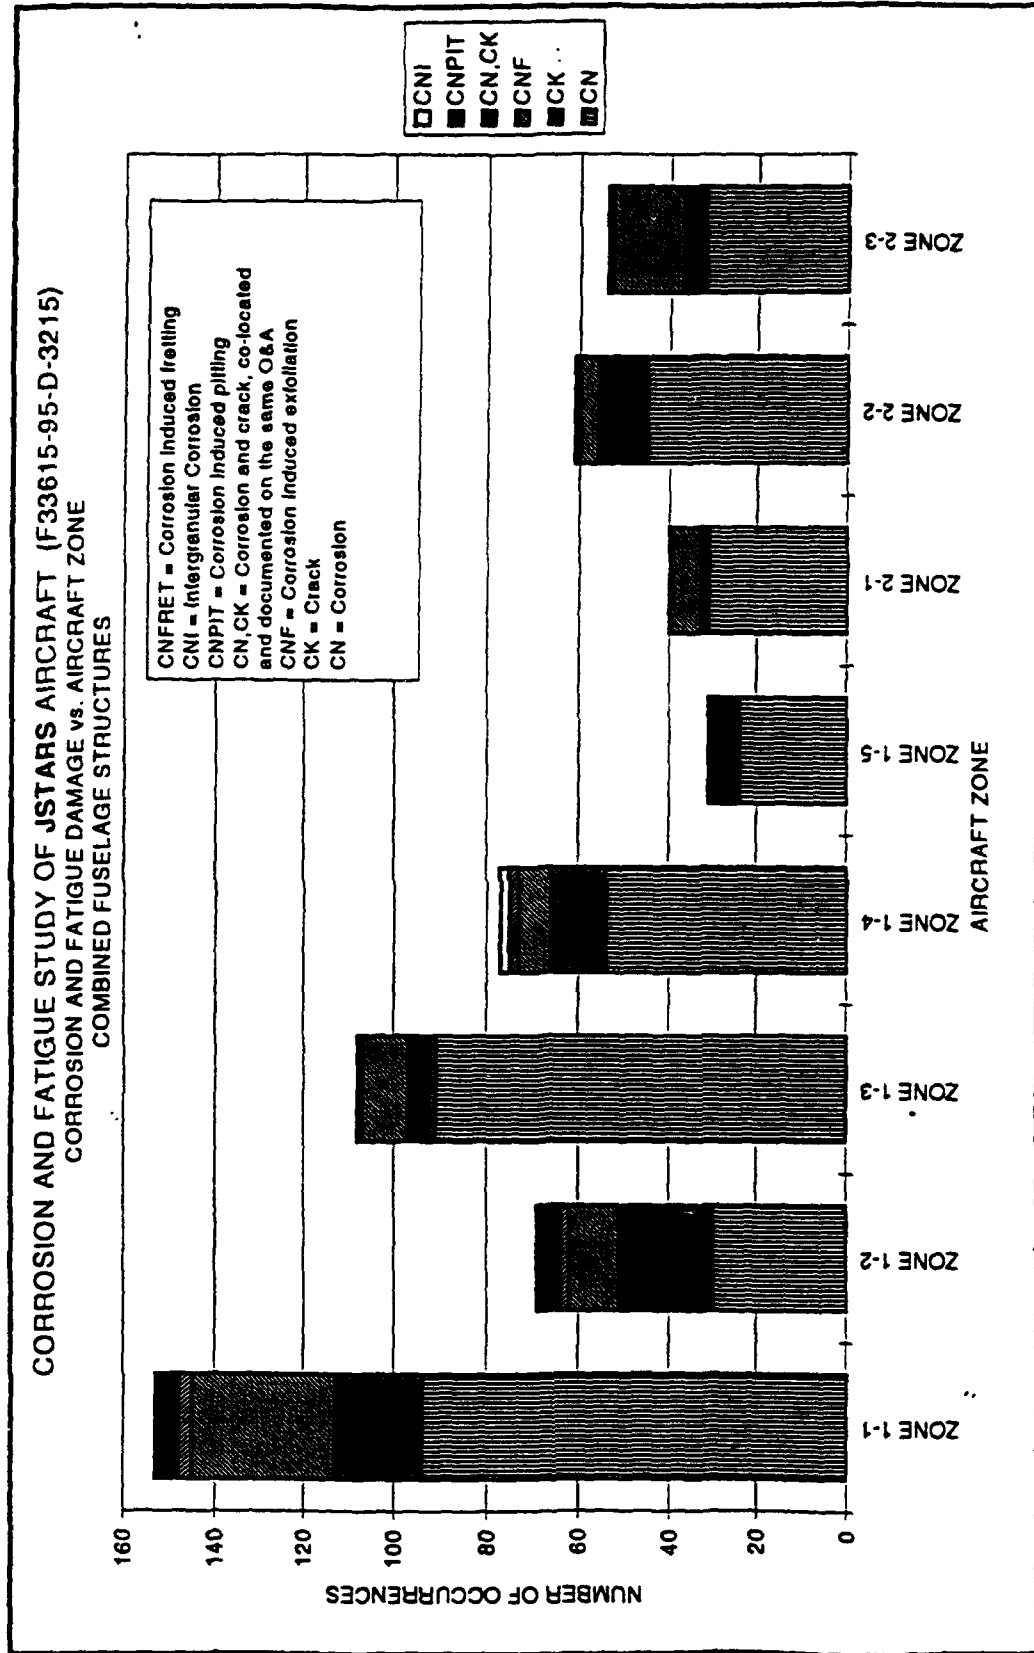
As shown in Figure 4.4, the internal structures of the lower fuselage zones of the aircraft surveyed were found to be the areas of highest corrosion and fatigue damage. Zones 1-1 through 1-4 consistently exhibited a higher level of damage than zones 2-1 through 2-3. This seems to disagree with Figure 4.1 which shows zone 2-3 with a higher level of damage than zone 1-2. However, Figure 4.4 only accounts for internal structures while Figure 4.1 includes skin panels and stringers.

Figure 4.4 - Corrosion And Fatigue Damage On Internal Fuselage Structures Per Aircraft Zone On Joint STARS Aircraft P3 And P4

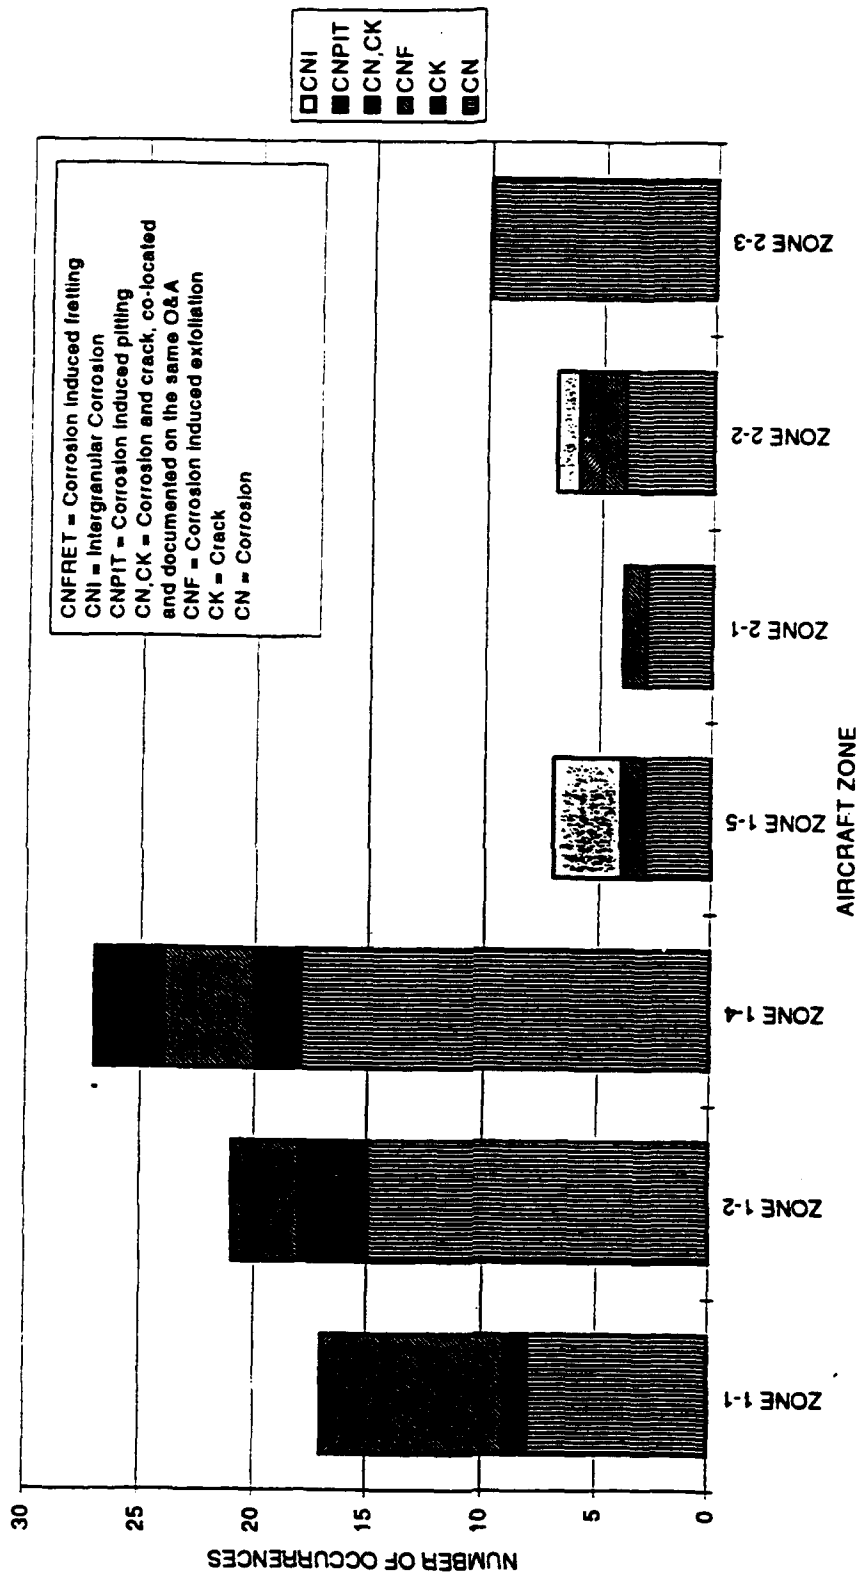
Fuselage stringers display the highest density of corrosion and fatigue damage in zones 1-1, 1-2, and 1-4, the belly of the aircraft. Further inspection within the aircraft zones does not reveal any strong patterns associated with the distribution of damage sites. In any given aircraft zone, the distribution of damage sites is fairly random with respect to body station and stringer number. Zone 1-4 displays the highest density of corrosion and fatigue damage, as indicated in Figure 4.8.

Figure 4.8 - Fuselage Stringer Corrosion And Fatigue Damage Per Aircraft Zone On Joint Stars Aircraft P3 And P4

- **LOWER FUSELAGE** Increased corrosion in the lower portion of the fuselage is readily explained by that region's exposure to splashed water from the ground and the propensity for external moisture to accumulate there. In addition to these external conditions, the lower regions are also subjected to moisture accumulation from within the aircraft, which gets trapped in the insulation and remains there for extended periods. This mechanism of internally generated corrosion is most evident in Figure 4.8, which shows the elevated corrosion levels of the lower stringers.

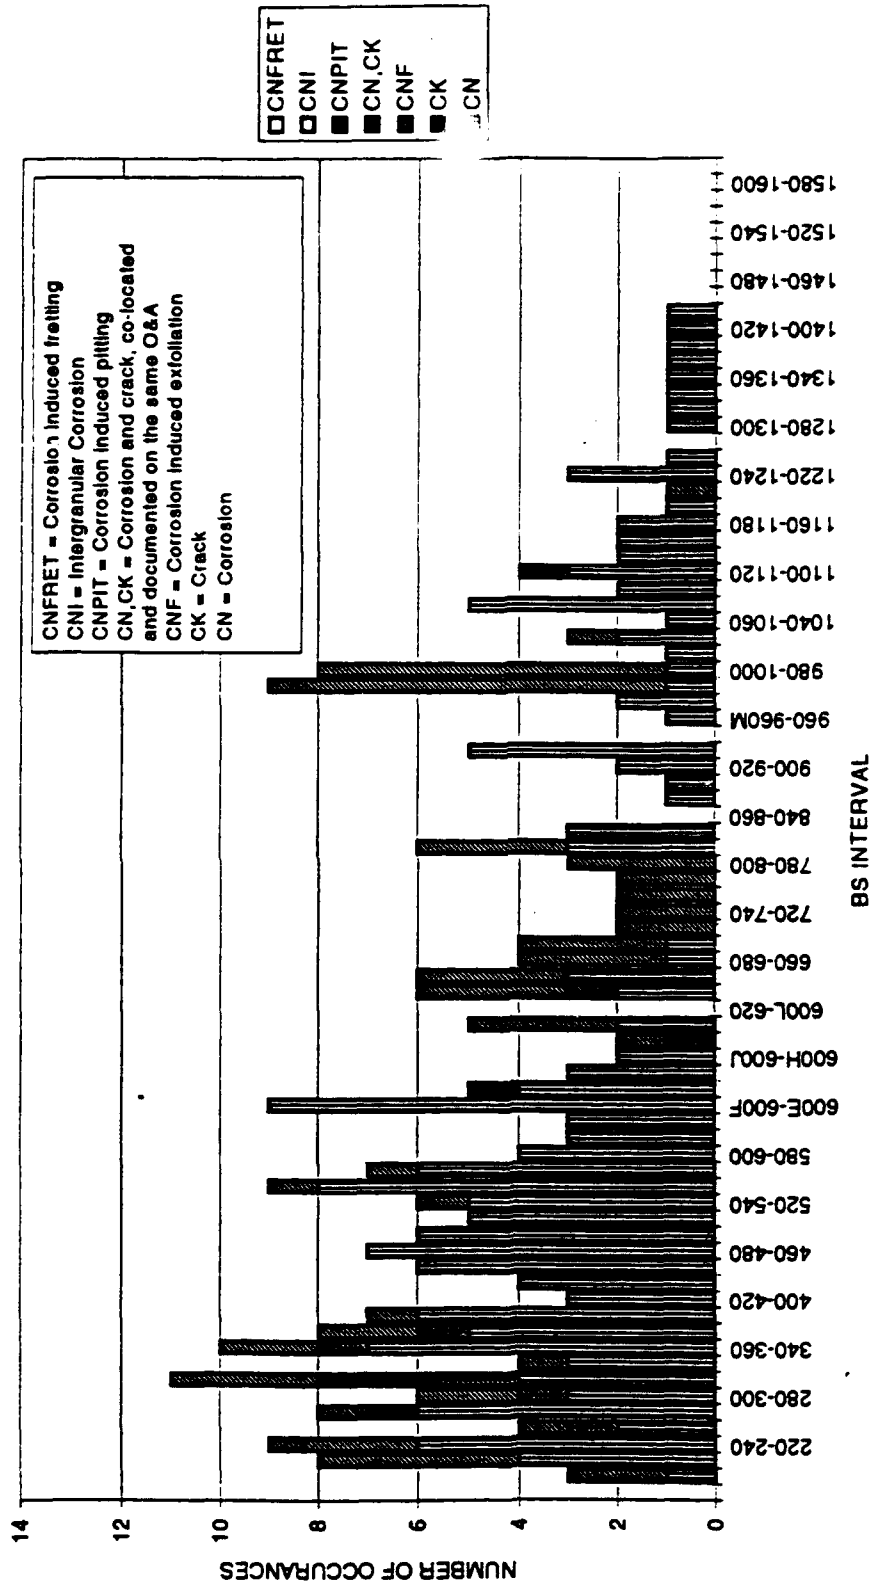
Figure 4.11 - Fuselage Floor Beam Corrosion And Fatigue Damage Per 20 Inch Segment On Joint STARS Aircraft P3 And P4

The aircraft zone containing the most defects is zone 2-4. The majority of floor beam corrosion and fatigue damage sites are located forward of BS 600K. Of particular note for the high level of damage sites are the floor structures from BS 200 to BS 400, and the area between BS 440 and BS 580. Further aft, the floor structures between BS 960N and BS 1000 are unique for their elevated levels of exfoliation. To a lesser degree, there is also an elevated level of exfoliation between BS 600J and BS 820, which is the floor above the center wing section. The corrosion and fatigue damage in the floor structures is represented in Figure 4.11.

crown skins The moisture introduced through this leak resulted in elevated corrosion in zone 2-2. The aircraft was used, in part, to carry livestock. The higher corrosion levels in the floor structures is believed to be the result of animal waste products in addition to the leakage from the crown skins.

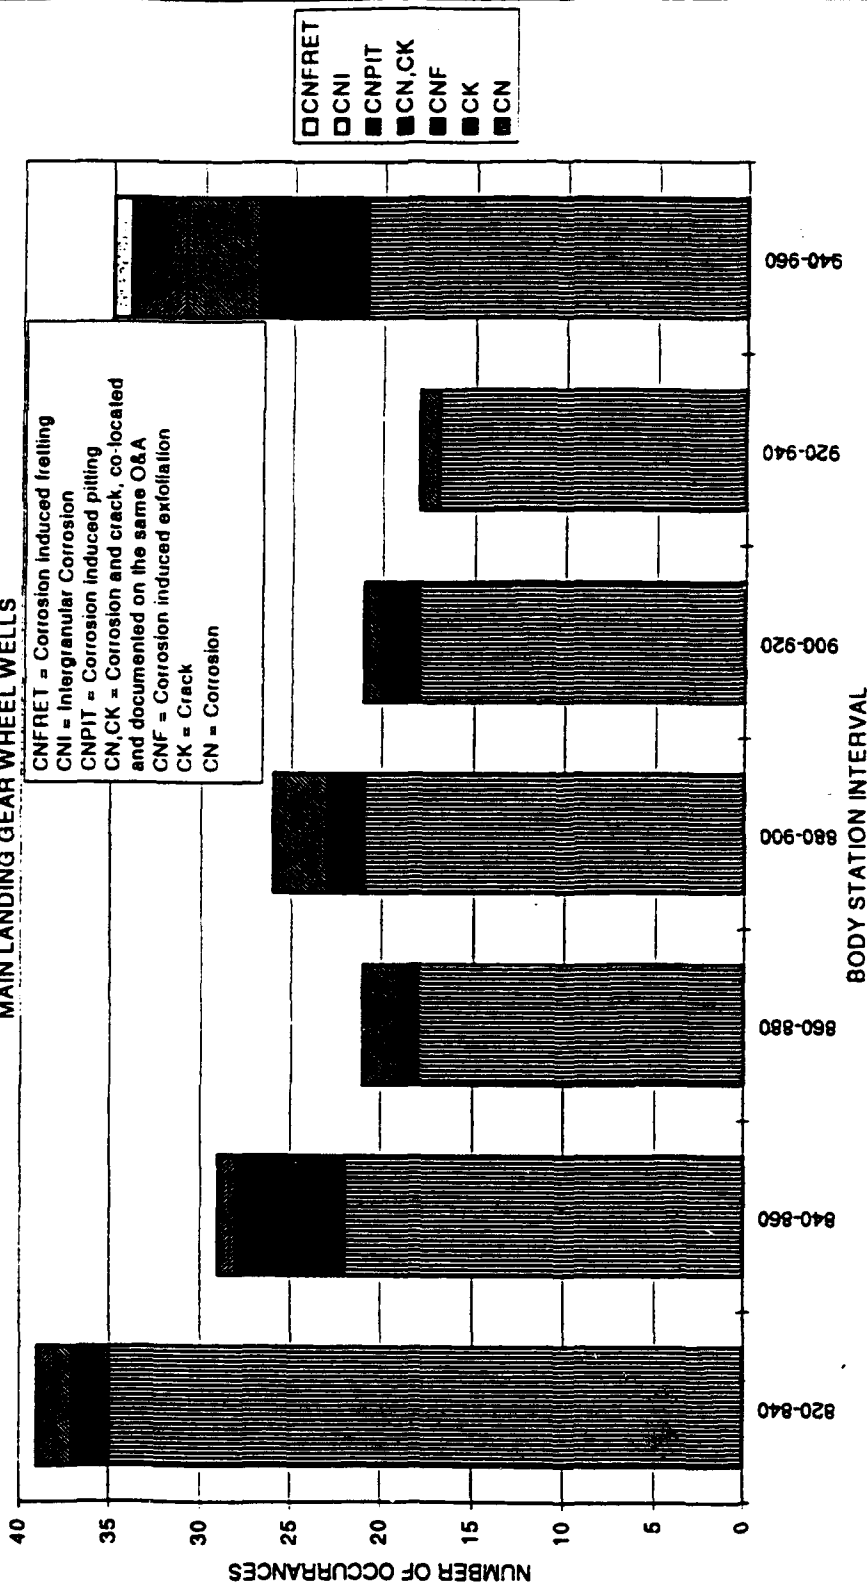
Figure 4.12 - Main Landing Gear Wheel Well Corrosion And Fatigue Damage Per Body Station Interval On Joint STARS Aircraft P3 And P4.

Aircraft zones 1-6 and 1-7 display high levels of corrosion and fatigue relative to zone size. The locations of the damage sites are presented in Figure 4.12, which segregates the data into 20 inch body station intervals. The level of damage per body station interval remains relatively level between BS 820 and BS 960. There are elevated levels of damage at BS 820 and BS 960, which are the fore and aft bulkheads of the wheel wells.

- **BS 820 - BS 960** The main landing gear wheel wells experience conditions very similar to those experienced by the nose landing gear wheel well. The up splash

from takeoff, landing and taxi introduces the conditions that initiate corrosion. The instances of reported cracking in this area are minimal.
